## 7.0 Green River, Utah, Disposal Site

### 7.1 Compliance Summary

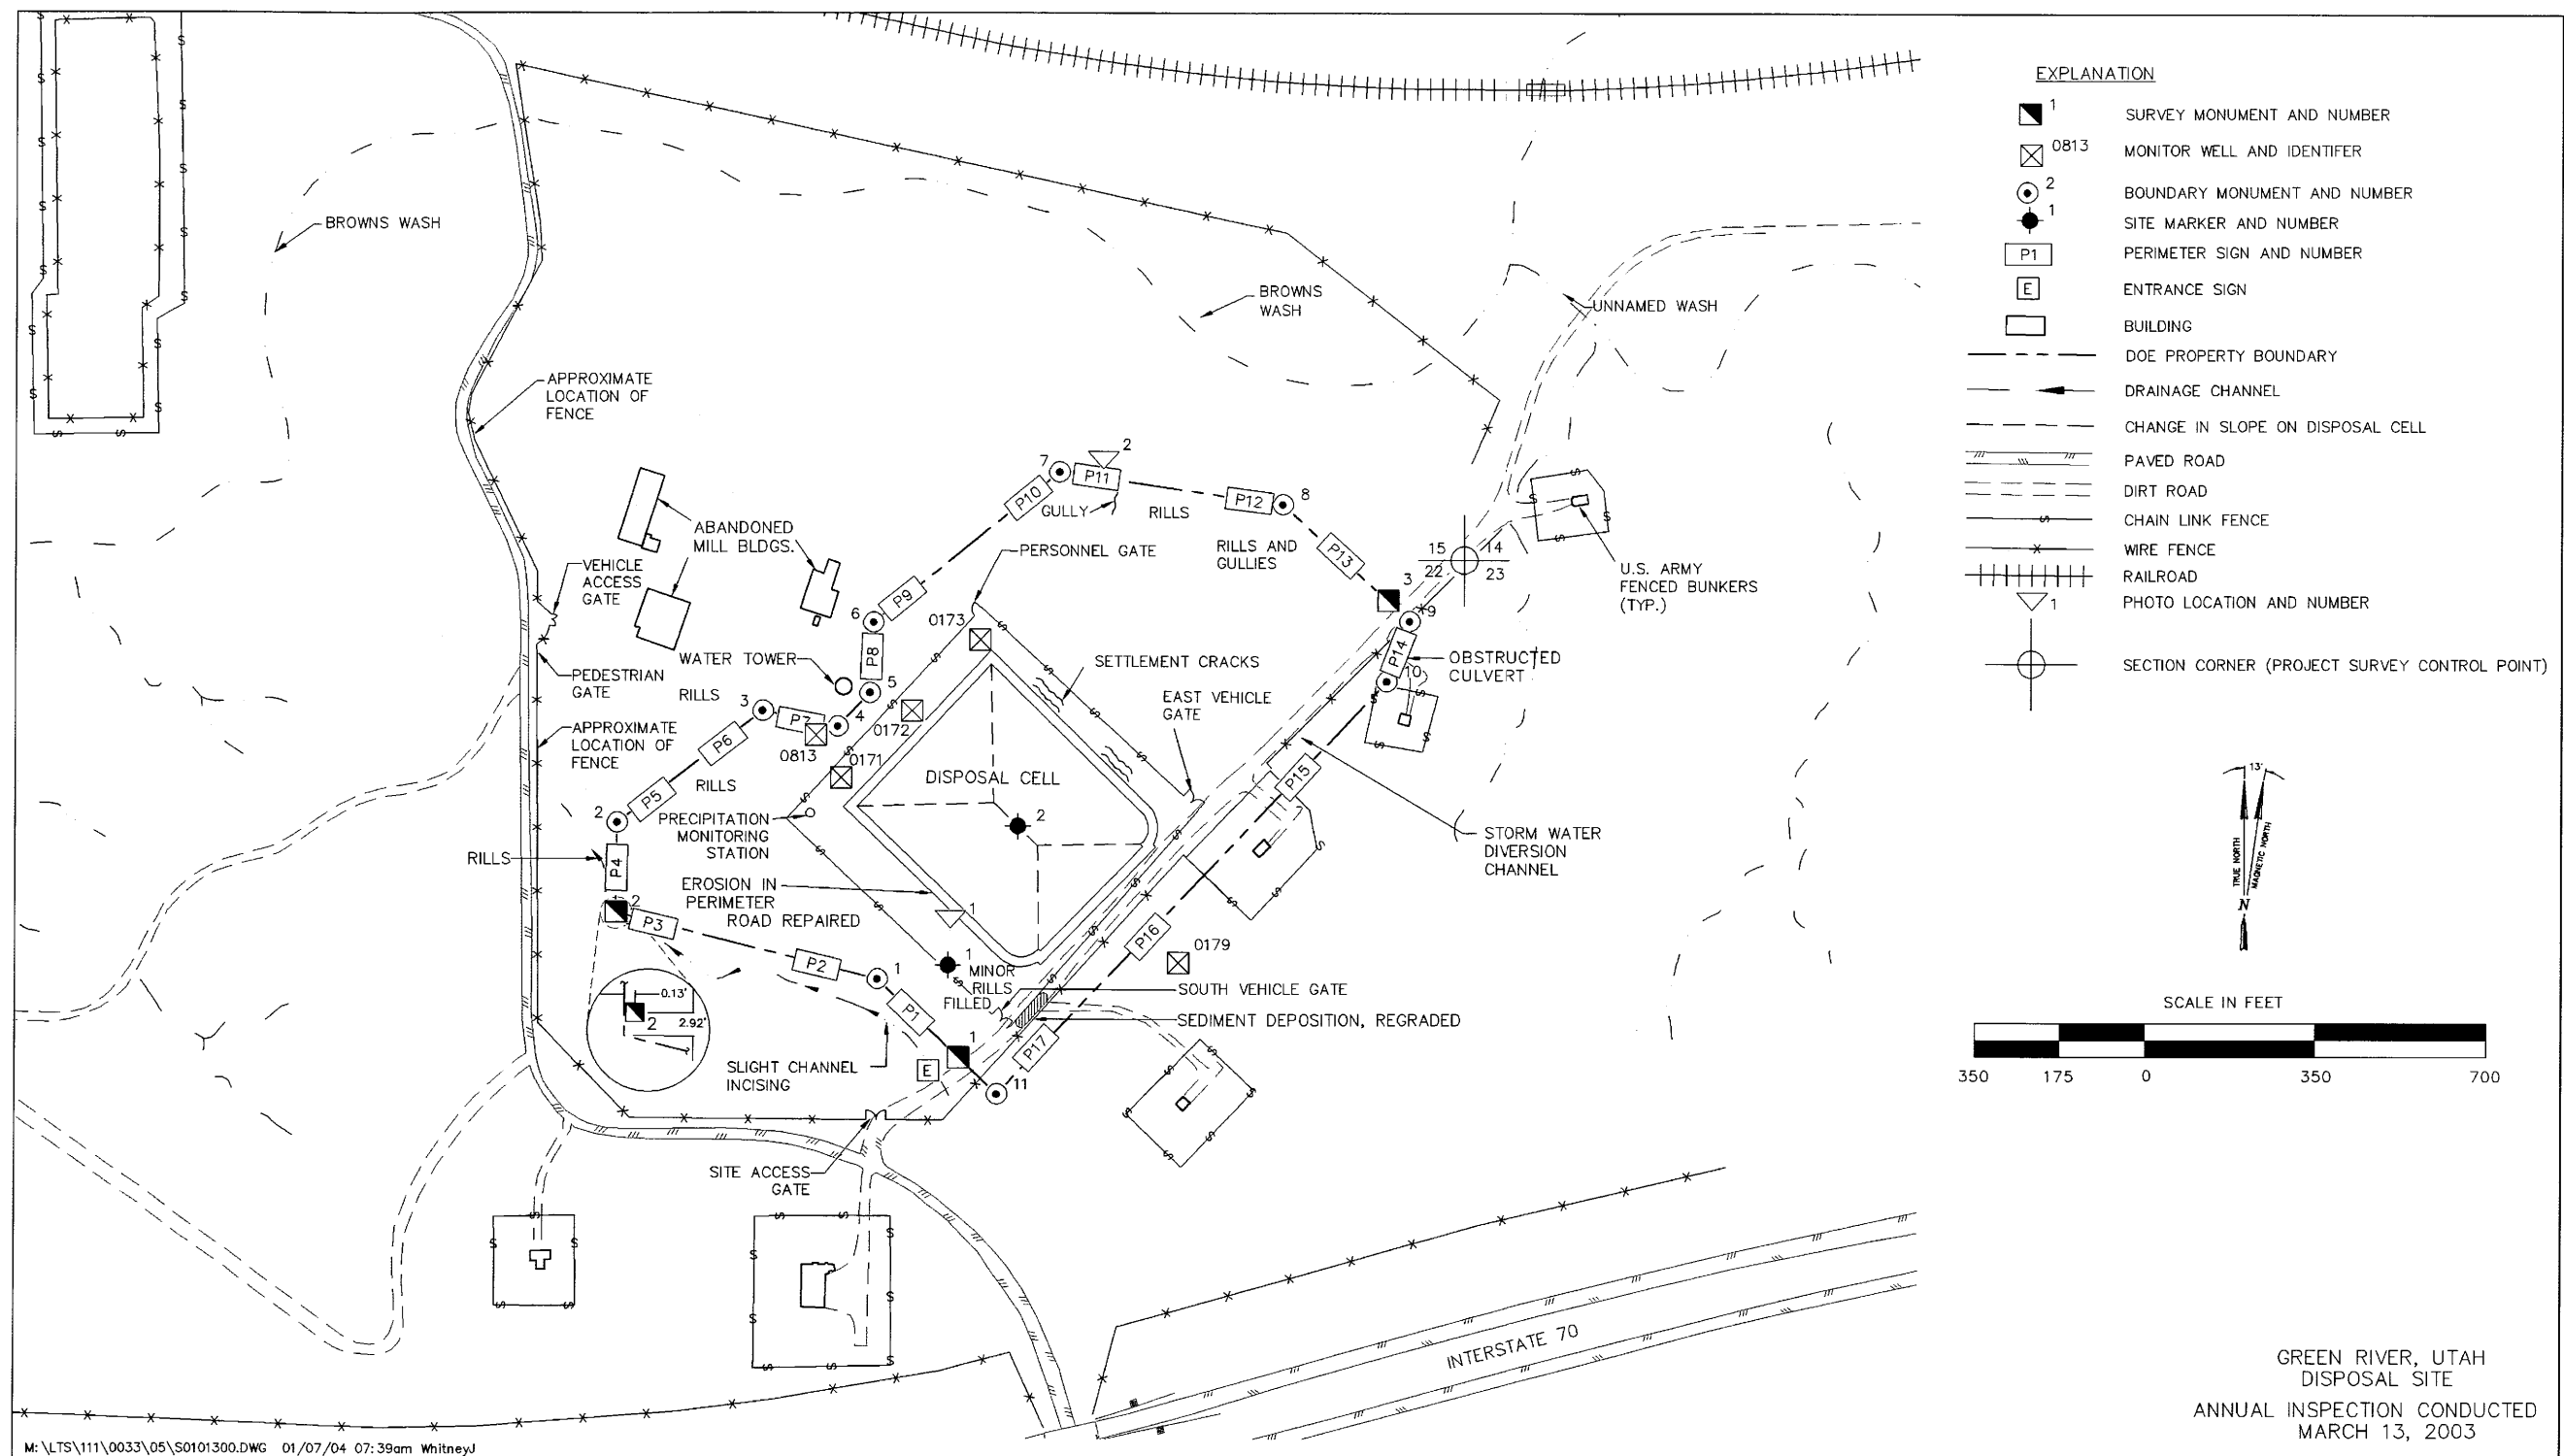
7B

Rill erosion on the west side of the property appears to have increased but does not pose a threat to the integrity of the cell. Site grading was performed to repair erosion damage and to divert runoff away from perimeter sign P4 and boundary monument BM-3.

Rill and gully erosion noted during previous inspections on the hillside northeast of the disposal cell in the area between boundary monument BM-7 and survey monument SM-3 appears to have increased (PL-2). Maximum gully depth in this area is approximately 3 feet. The rill and gully erosion poses no threat to the integrity of the disposal cell but eventually could damage perimeter signs and boundary monuments; therefore, monitoring of erosion in this area will continue.
